CHILE 2010 EARTHQUAKE

An overview and a lesson learned

Peter Fajfar and Matej Fischinger
University of Ljubljana, Slovenia

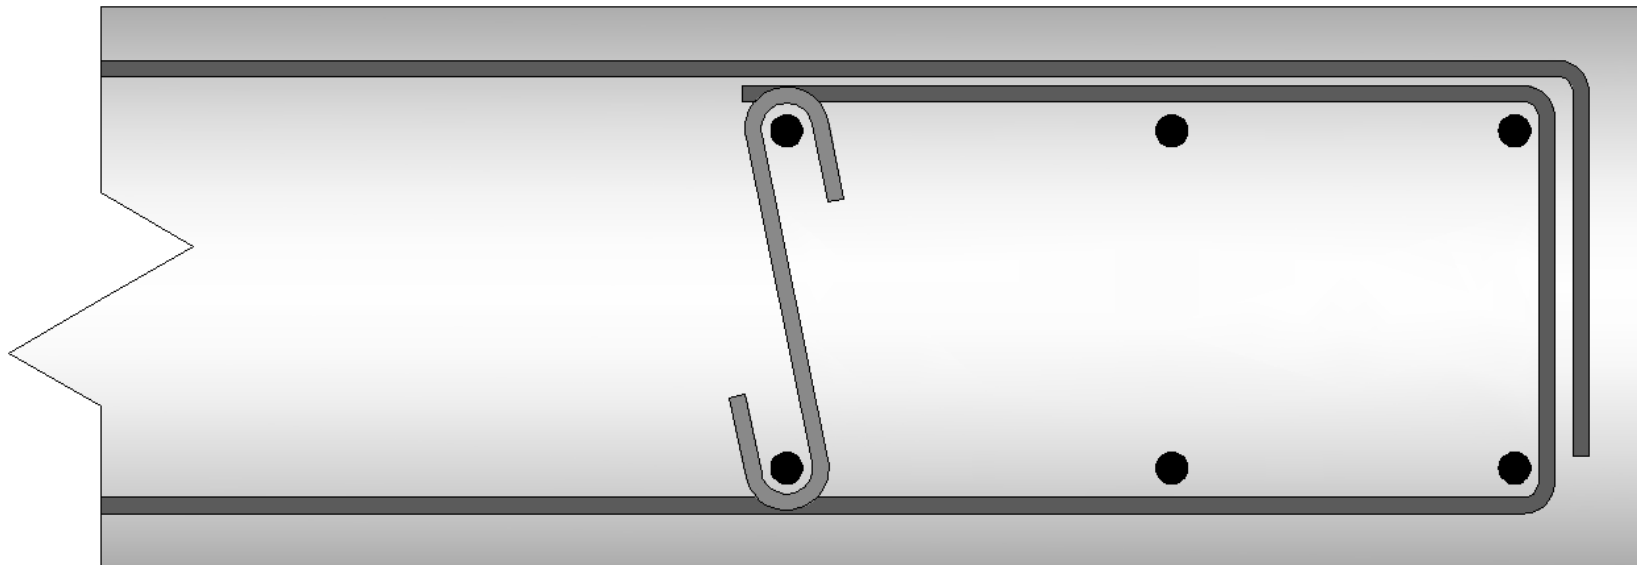
Anchorage of the horizontal reinforcement in walls

Design practice in Chile

- EC8 requirements could prevent such compressive failures.
- The wall-to-floor area limitation (related to the number of floors) is still missing
- Anchorage of the horizontal reinforcement into confined boundary areas is not specified

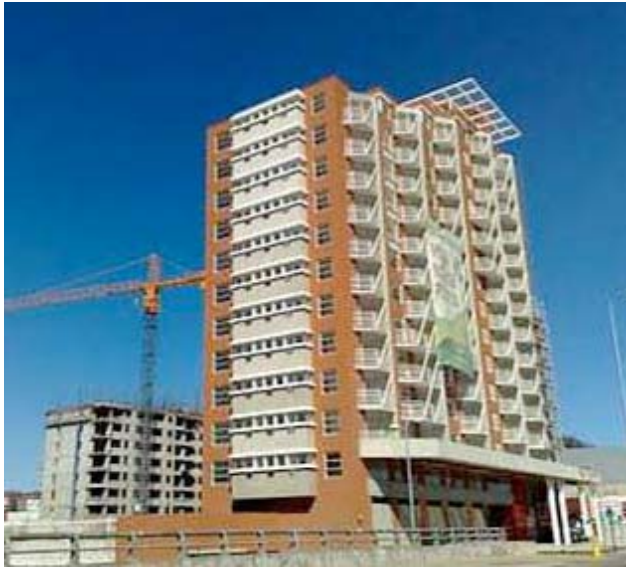
Alto Rio, Concepcion

Before Earthquake

- 15 Stories, RC, Housing
- 2 Underground Levels
- Built in 2008

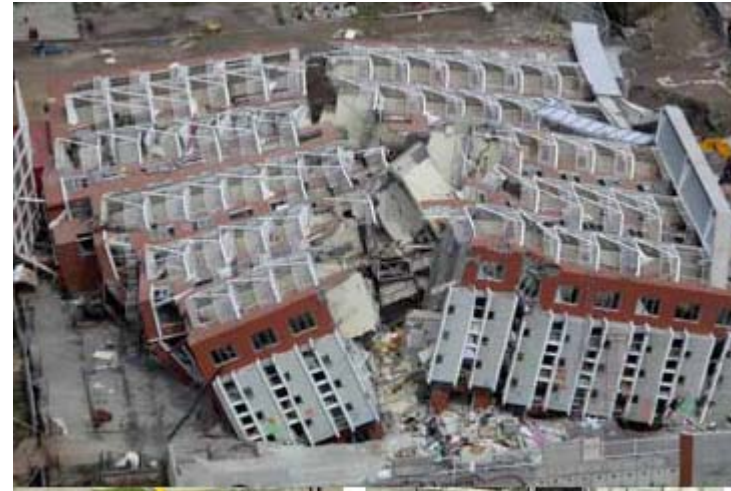
After Earthquake

- At the moment of the earthquake in the building only 87 people were in there:
 - 8 died
 - 79 survived: 52 got out of the building by their own, 27 were rescued from the debris

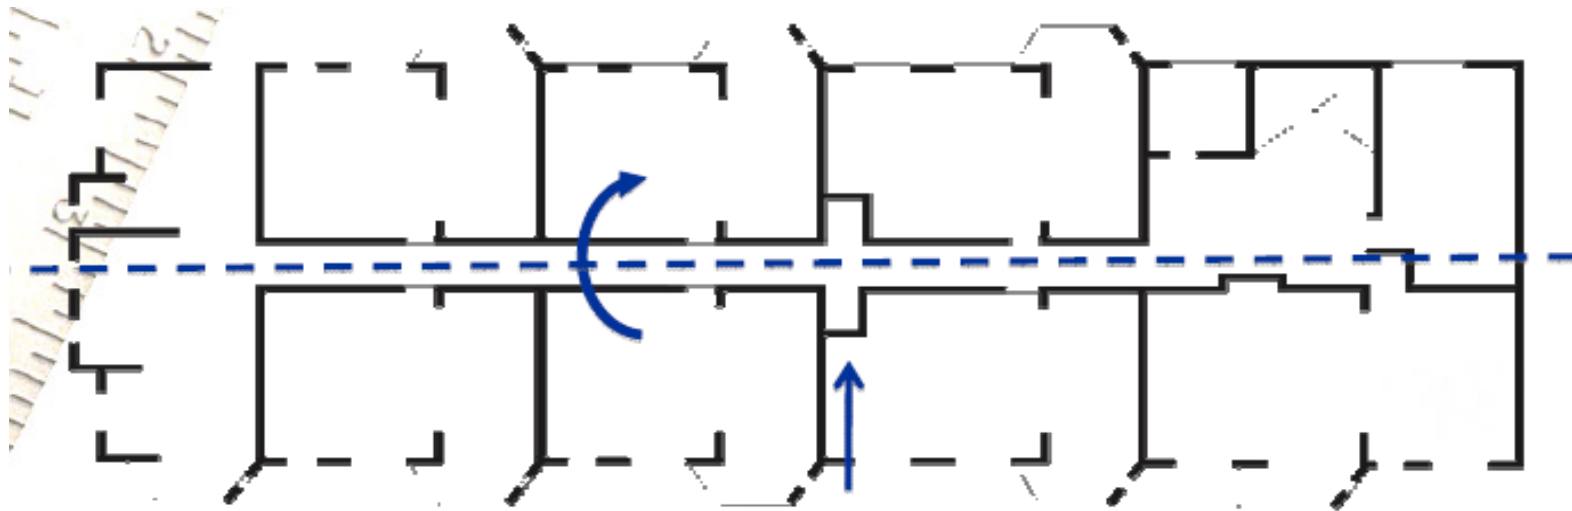
Sketch Floor Plan

Alto Rio

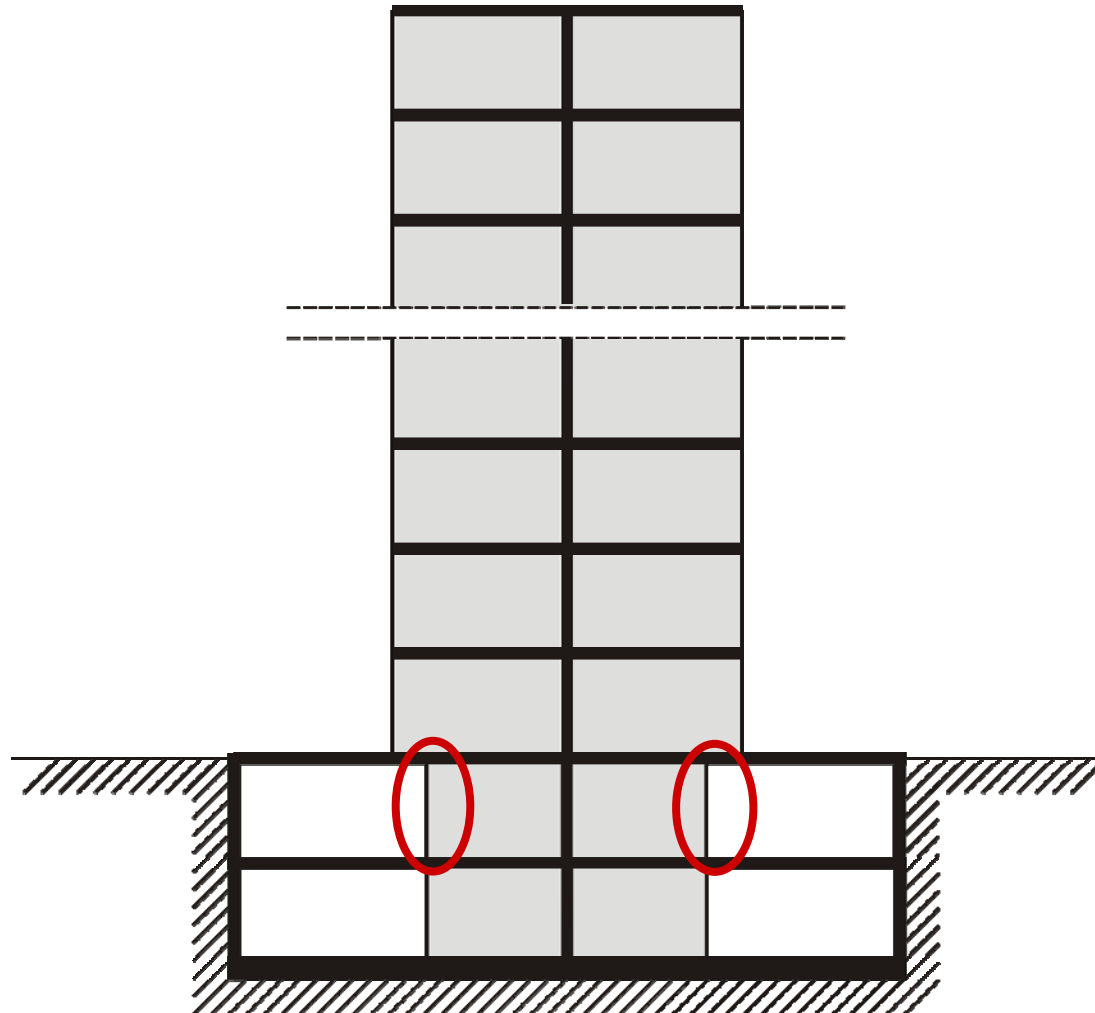
First basement

- New observation: Systematic failures of slender walls with high compression in new buildings
- In particular in first basement
- Failure was local and brittle. Inadequate confinement (for high axial stress). Loading could not be transmitted to the peripheral basement walls

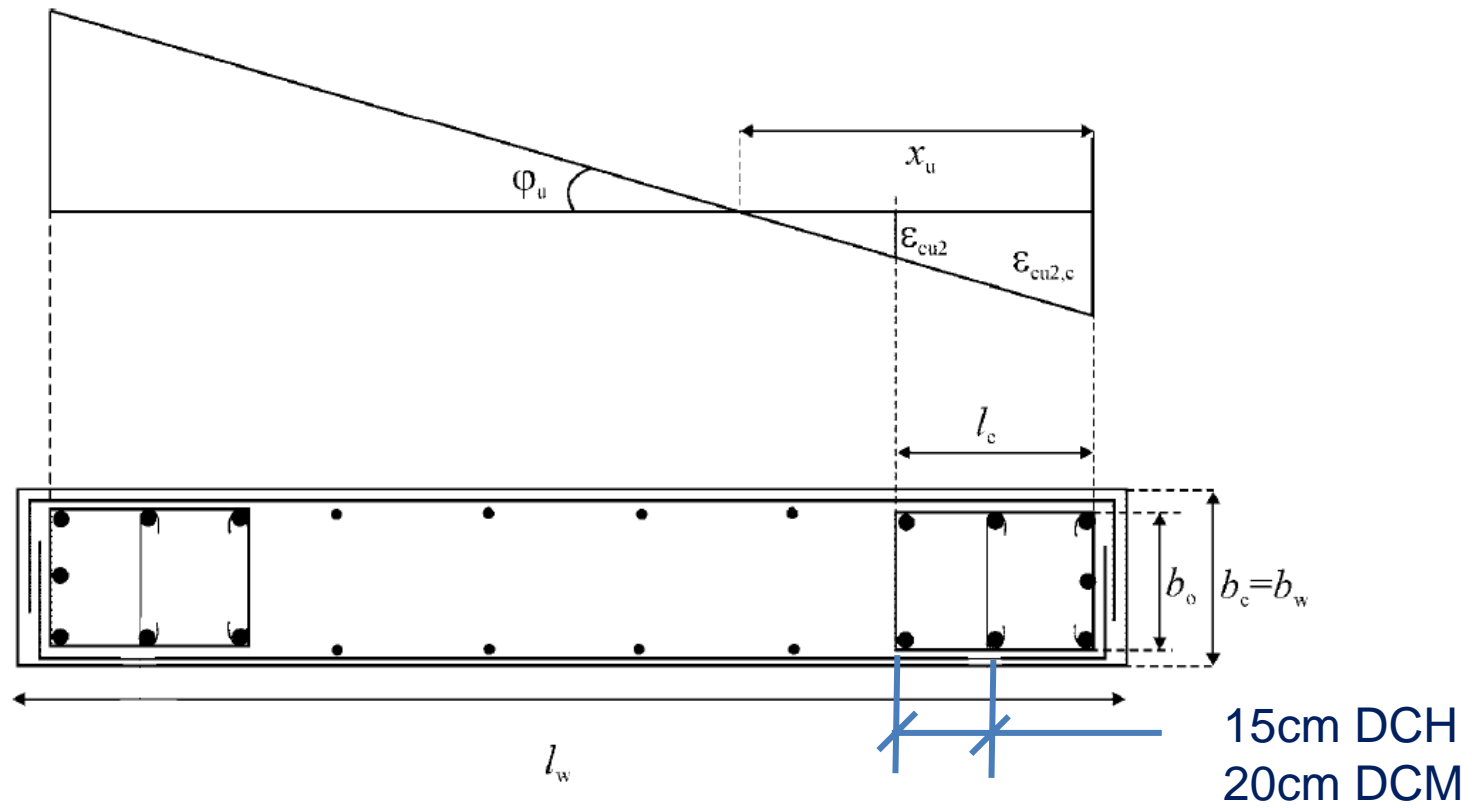
EC8

Axial stress limitations

Chile:	None		
EC8:	$\sigma \leq 0.40 \cdot f_{cd}$	DCM	
	$\sigma \leq 0.35 \cdot f_{cd}$	DCH

EC8: No confinement required only if
 $\sigma \leq 0.15 \cdot f_{cd}$ DCM
