CHILE 2010 EARTHQUAKE

An overview and a lesson learned

Peter Fajfar and Matej Fischinger
University of Ljubljana, Slovenia

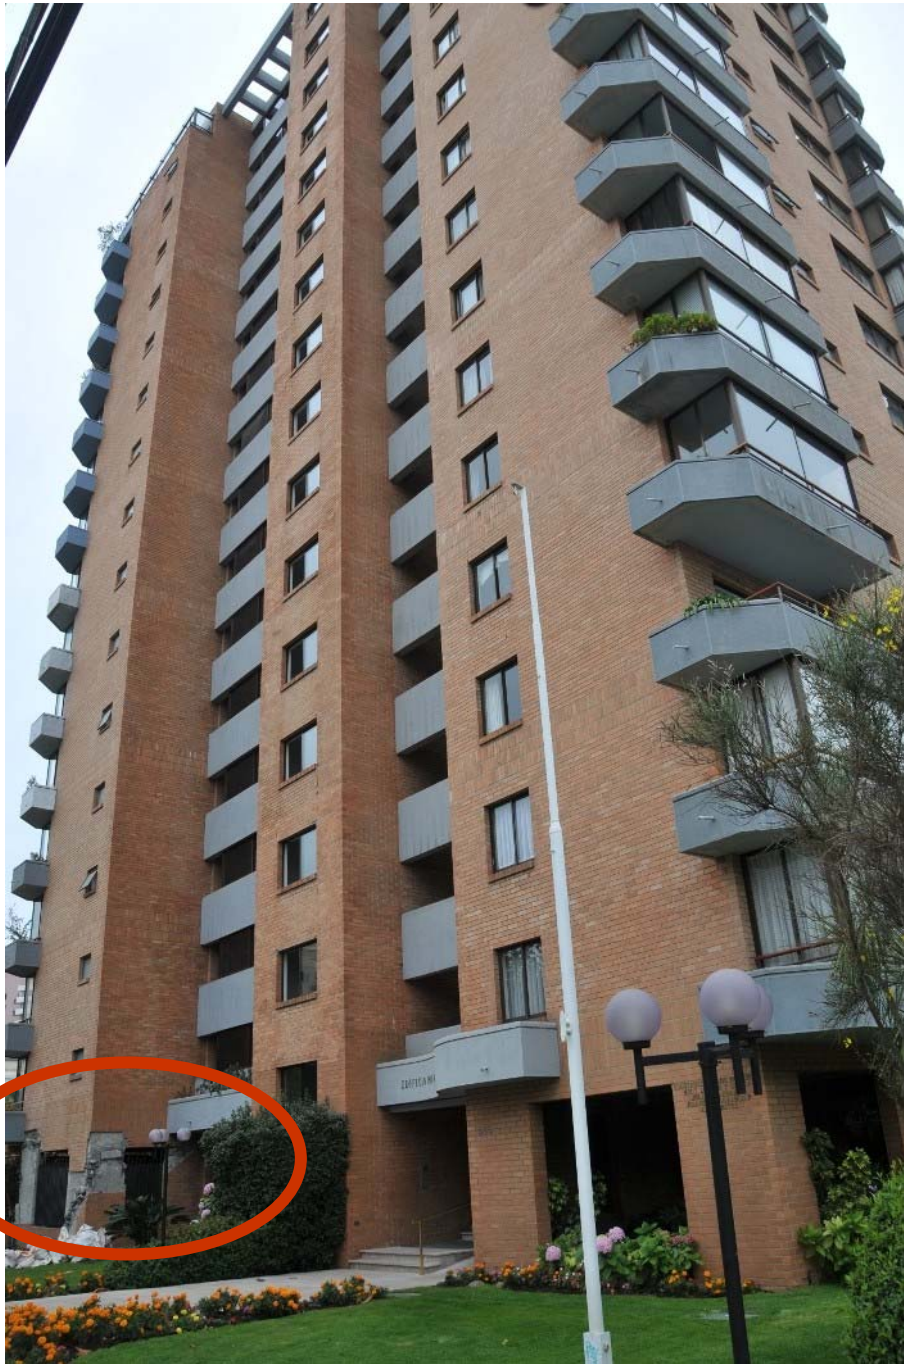
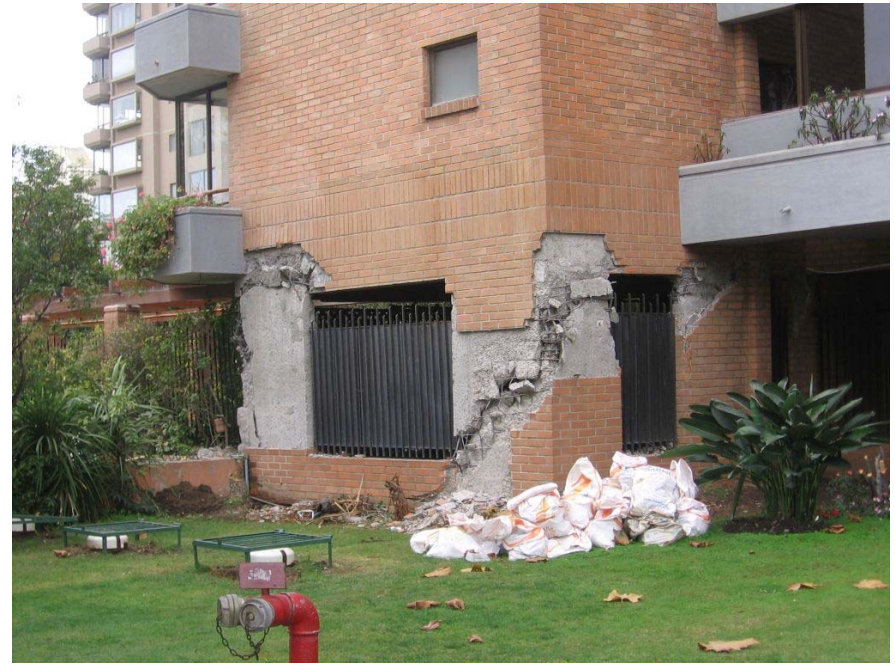
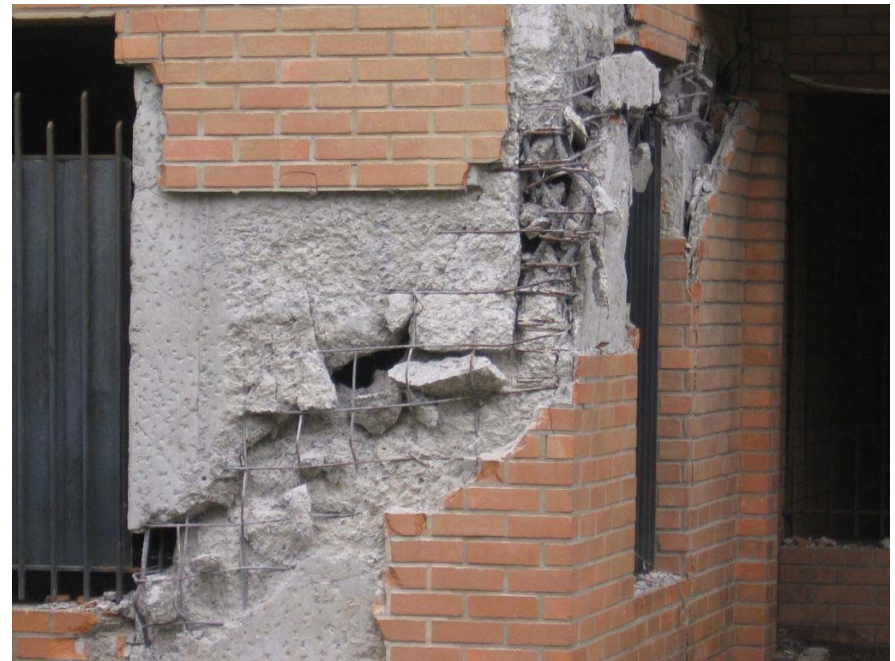
First basement

- New observation: Systematic failures of slender walls with high compression in new buildings
- In particular in first basement
- Failure was local and brittle. Inadequate confinement (for high axial stress). Loading could not be transmitted to the peripheral basement walls

- EC8 requirements could prevent such compressive failures.
- The wall-to-floor area limitation (related to the number of floors) is still missing
- Anchorage of the horizontal reinforcement into confined boundary areas is not specified

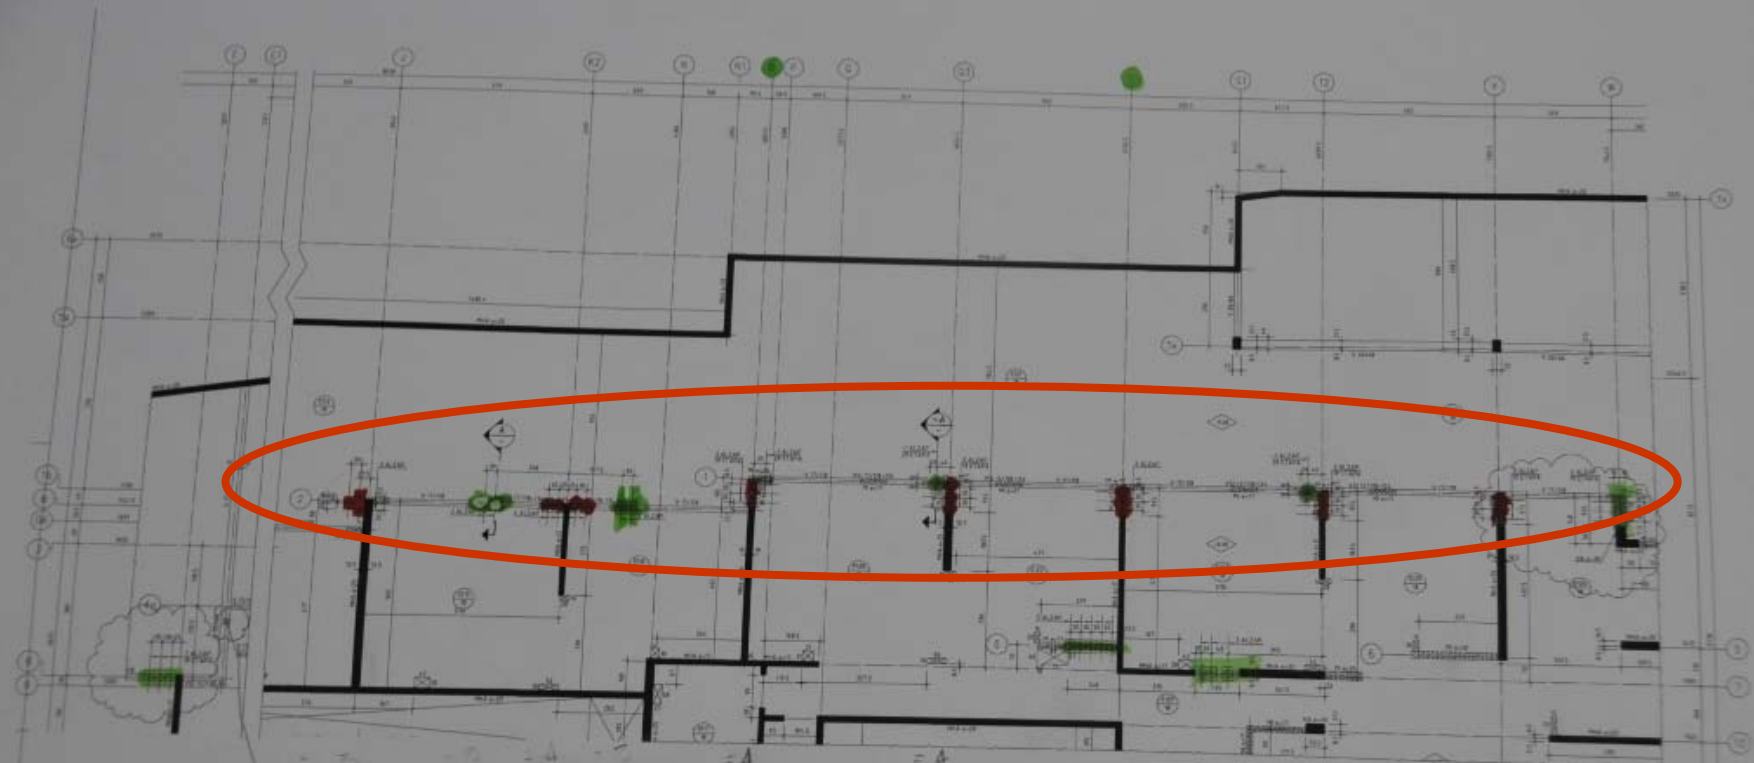
PLANTA CIELO 1º SUBTERRÁNEO

INHABITABLE
